VACUUM JACKETED UMBILICAL LINES
TECHNOLOGY ADVANCEMENT STUDY

VACUUM PROBES

Final Technical Report, Task V
Contract Number NAS 10-6098

NATIONAL AERONAUTICS AND SPACE ADMINISTRATION
John F. Kennedy Space Center
Design Engineering - Mechanical Systems Division
J. B. Downs, Project Manager
Kennedy Space Center, Florida 32899

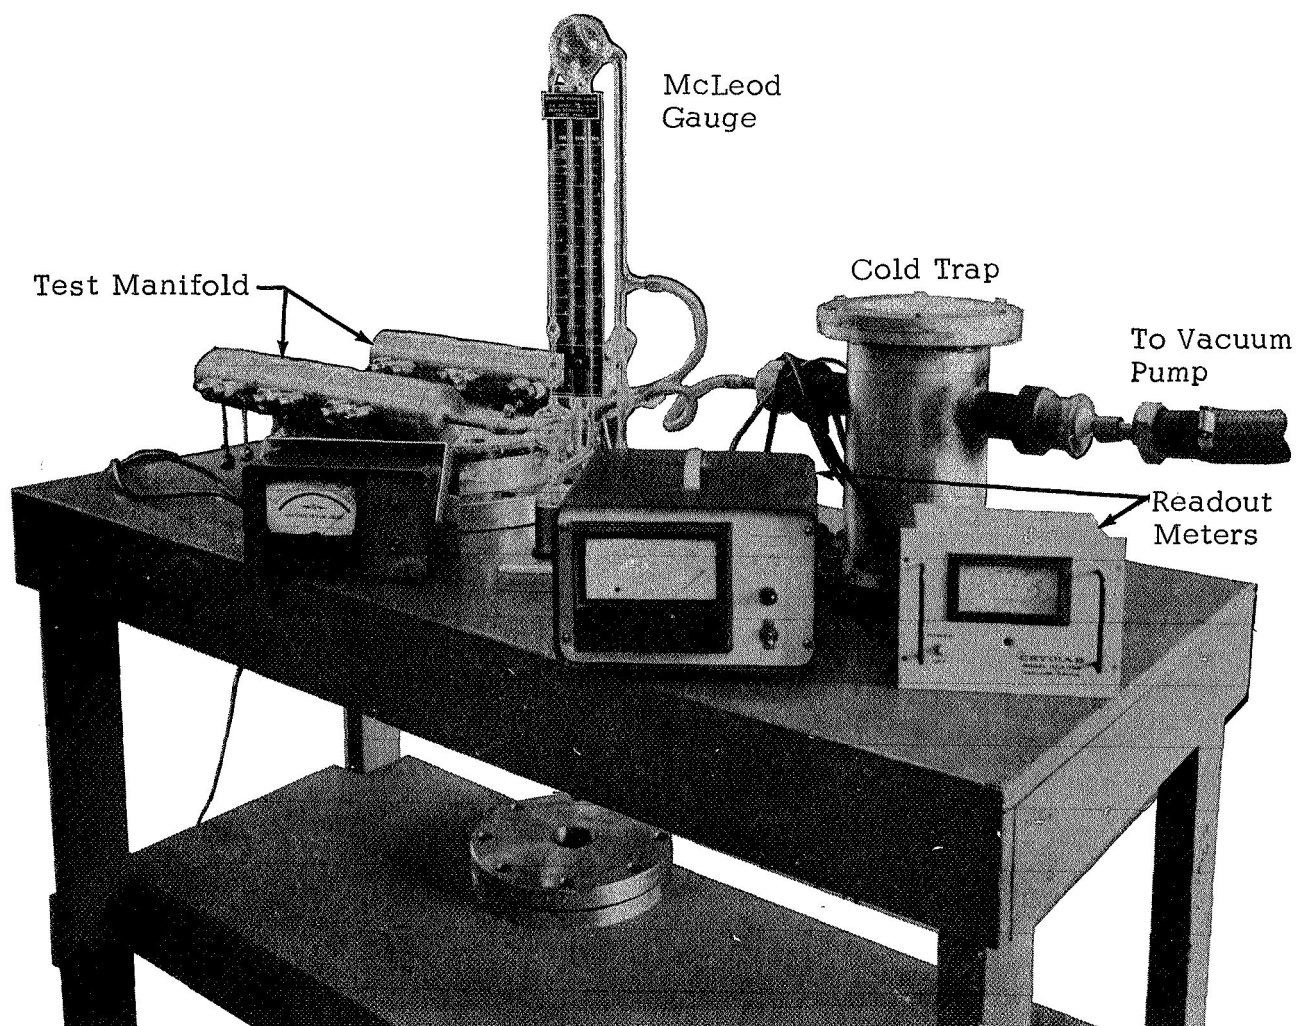
Figure 22.
Vacuum Probe Test Setup

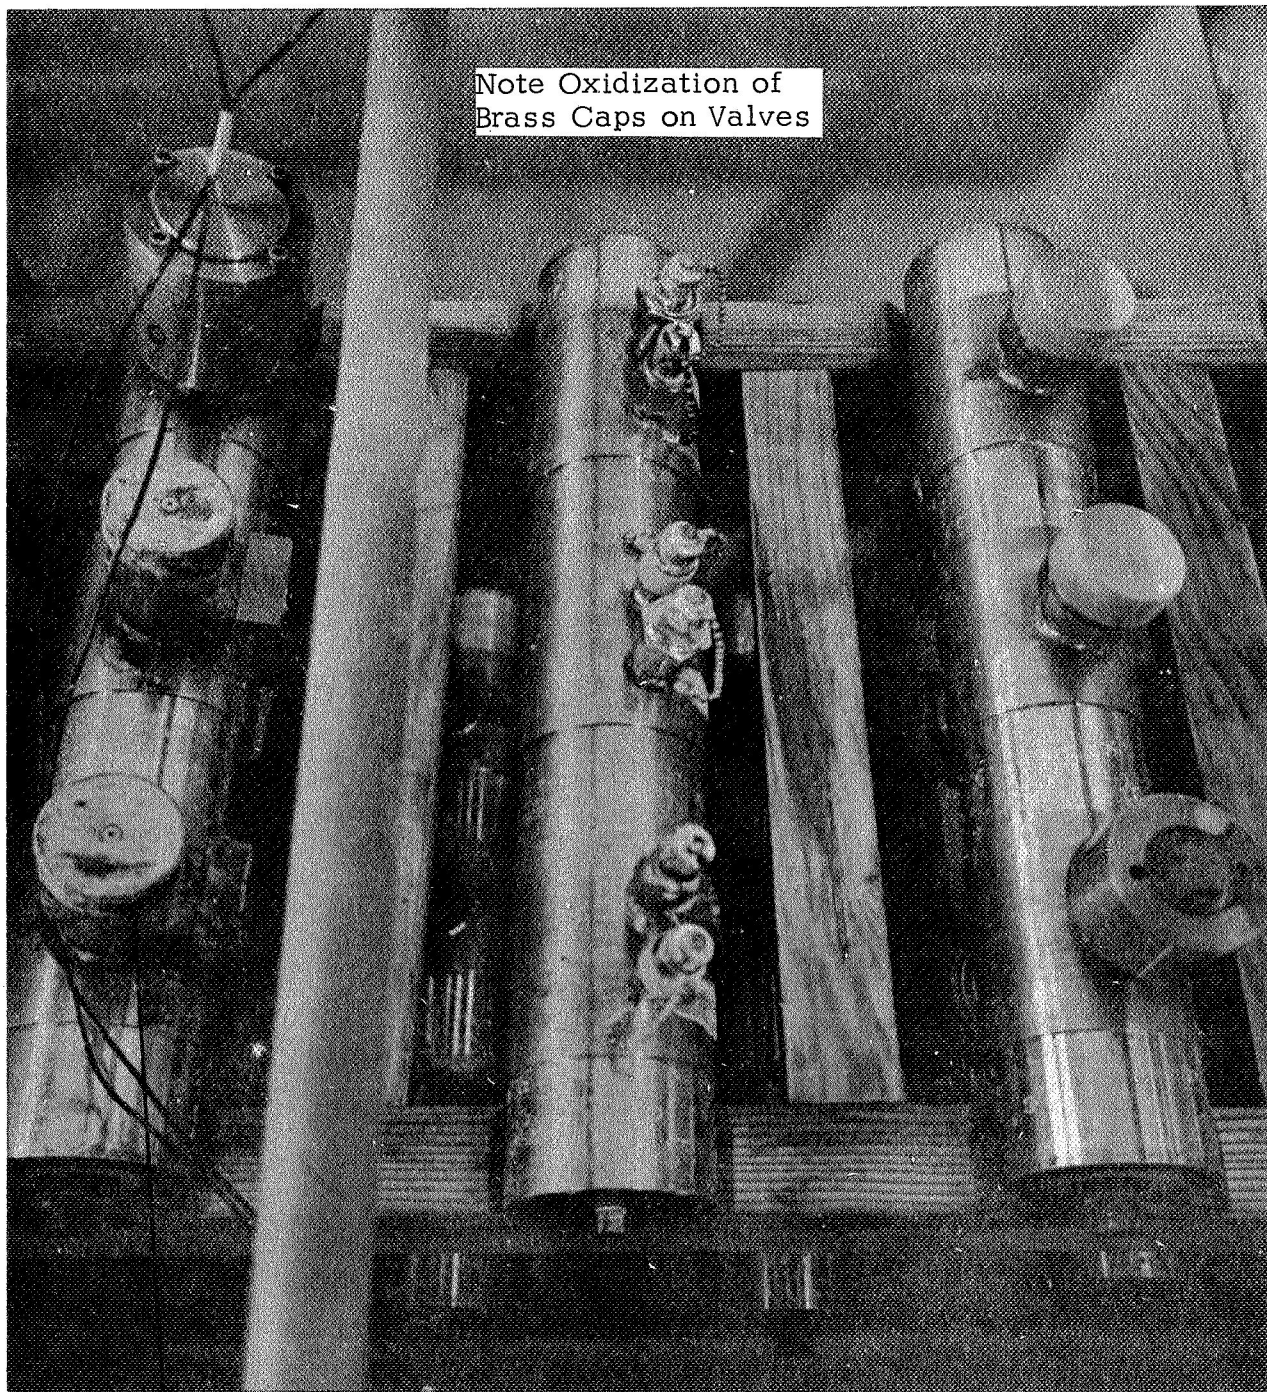
Note 304 Stainless
Steel Port Cap Corrosion

Note Drainage From
Vacuum Probe Caps

Figure 25.
Vacuum Seal Valves, Vacuum Probes, And
Burst Discs Following Salt Fog Test

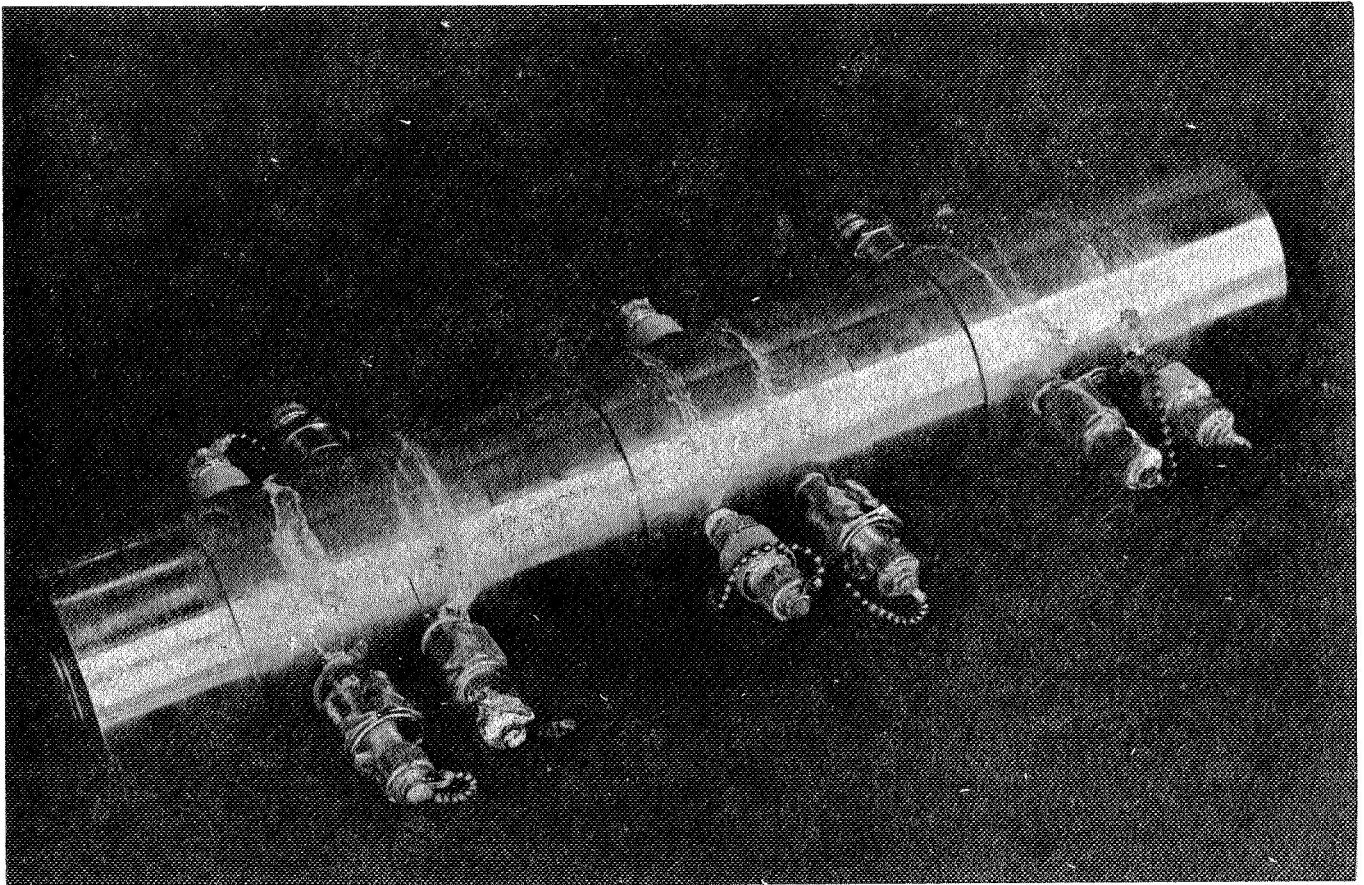
Figure 26.
Vacuum Probe Specimen After Salt Fog Test

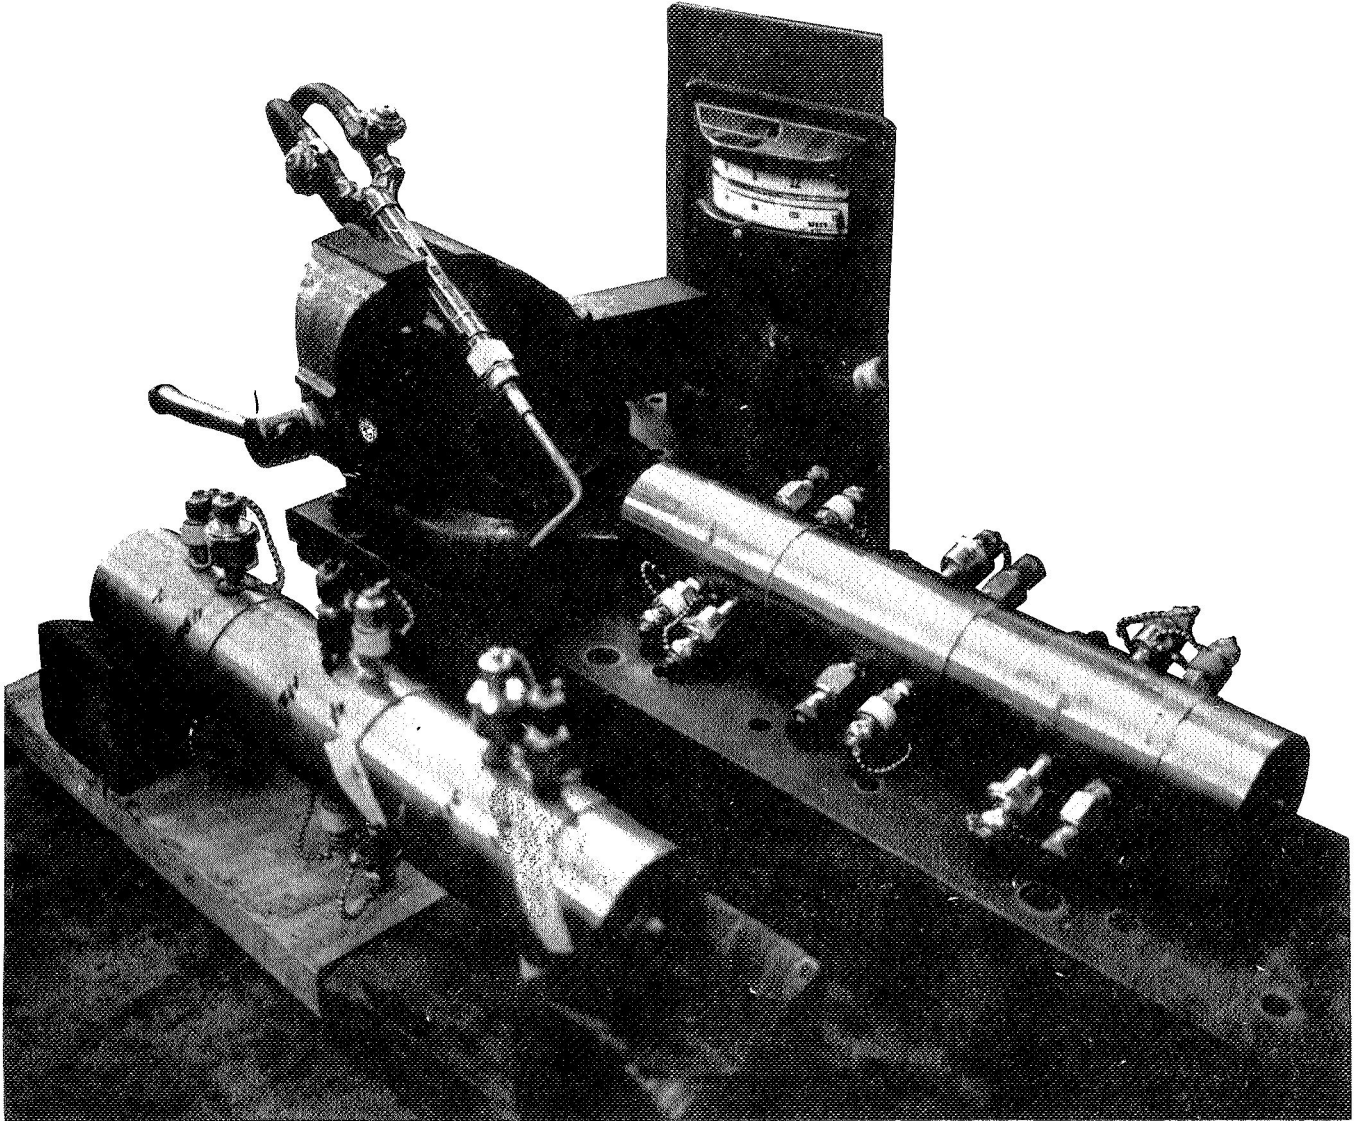
Figure 27.
High Temperature Test Setup for the Thermocouple Probes

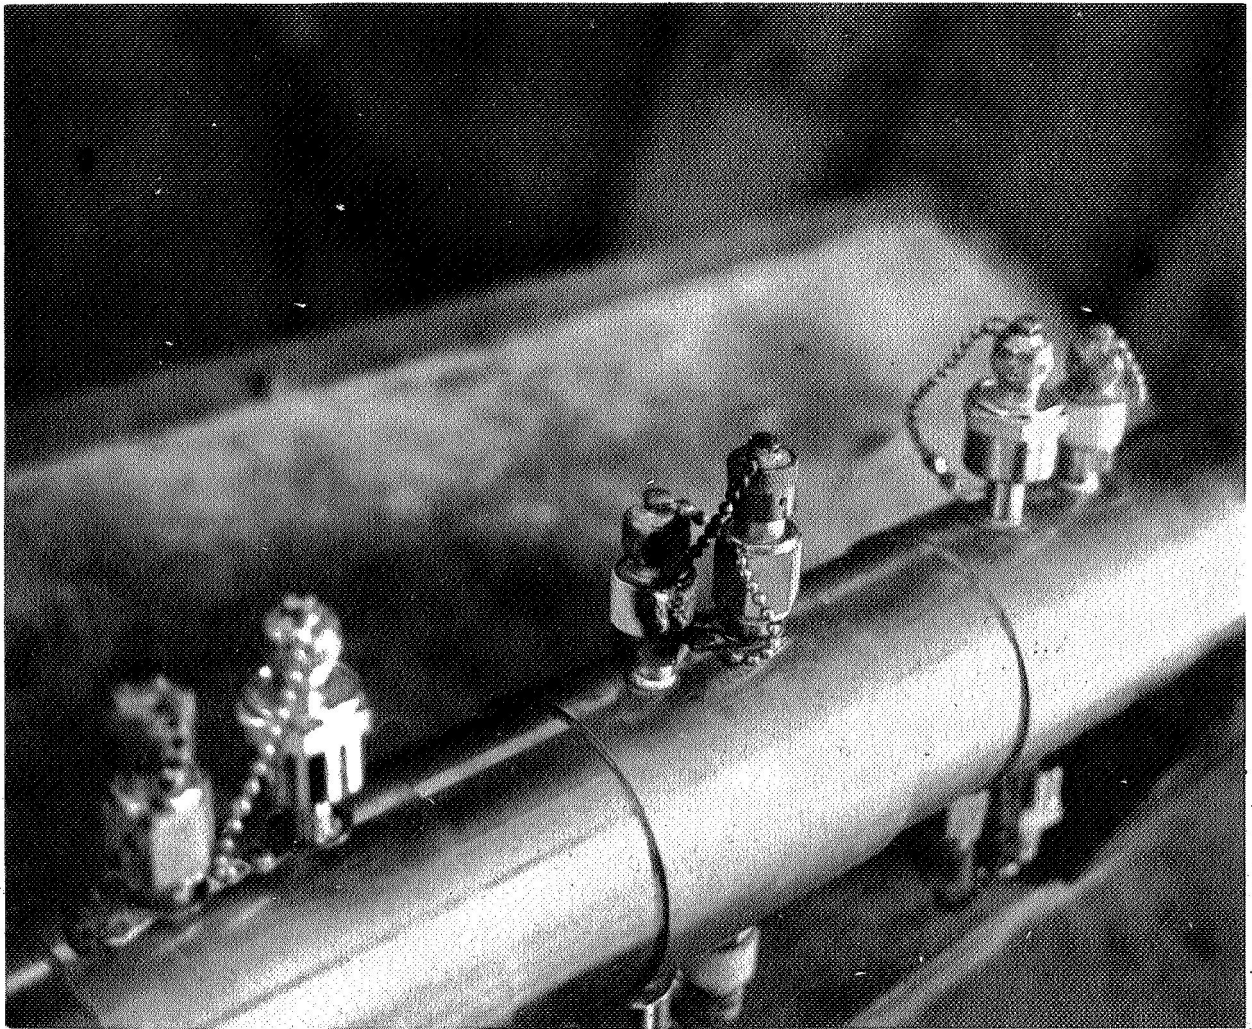
Figure 28.
Result of Heat on the Bumper Guard on the Fredericks T.T. Gauge

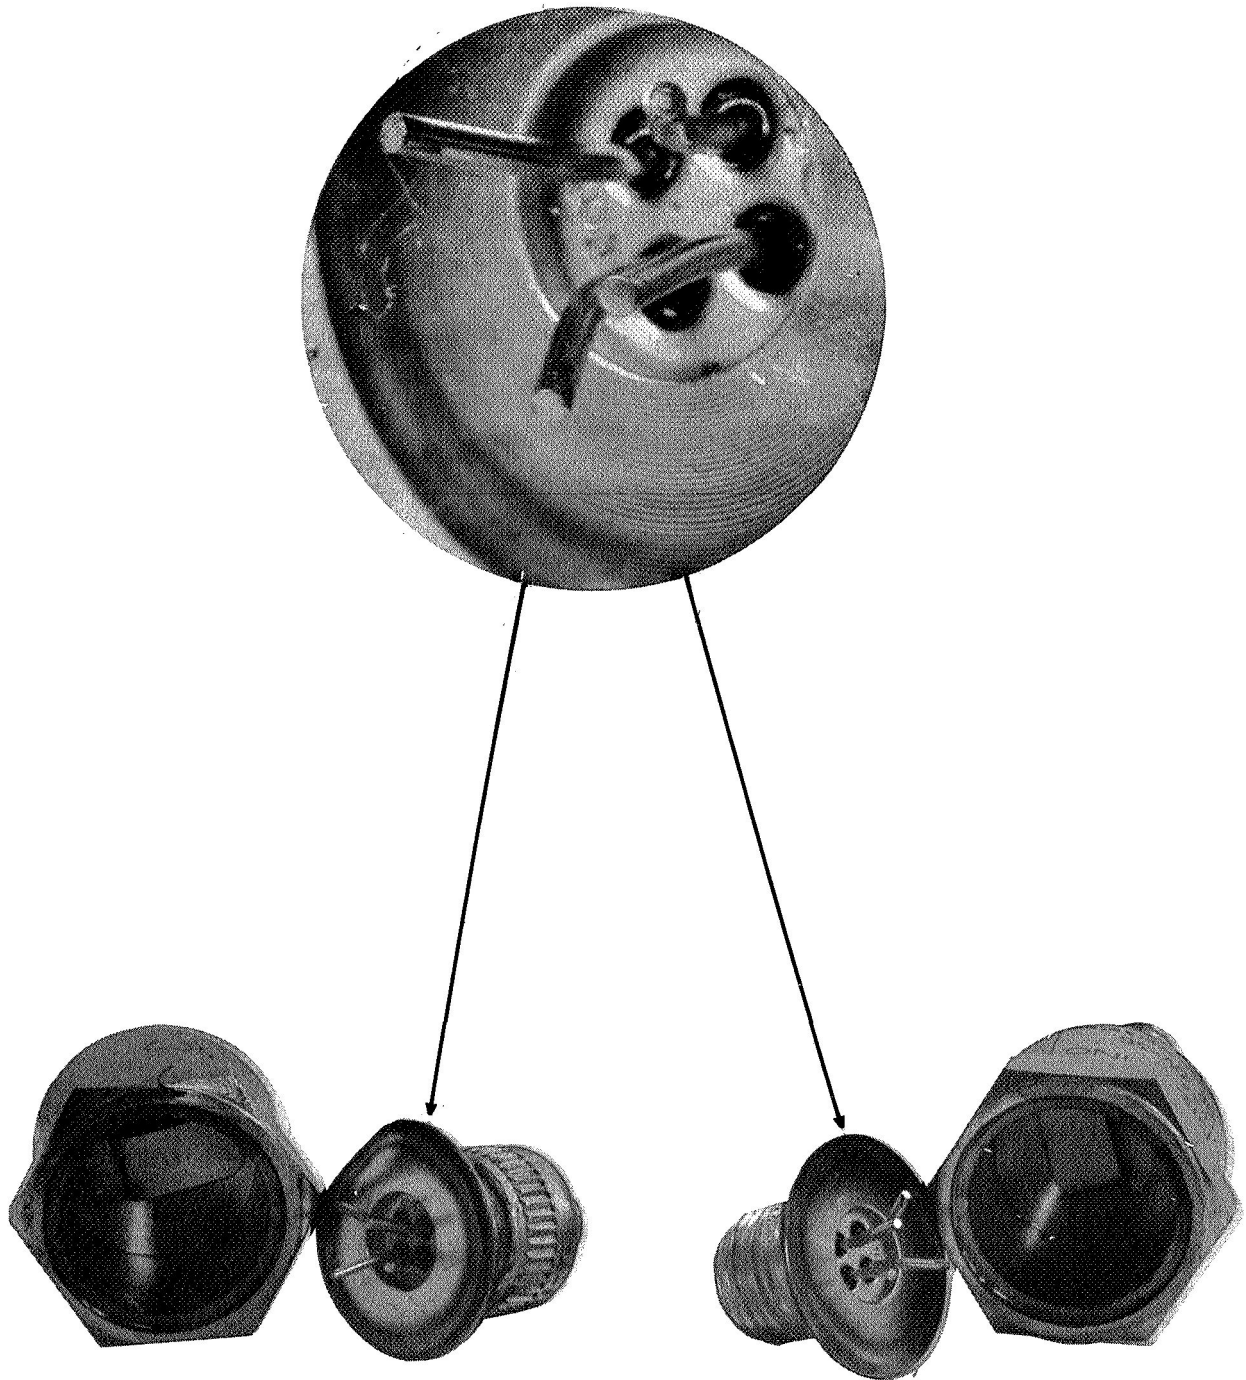
Figure 32.
Failure Analysis After Vibration Of The Hasting Vacuum Gauge
Showing The Sensing Wires Broken Away From The Mounting Posts

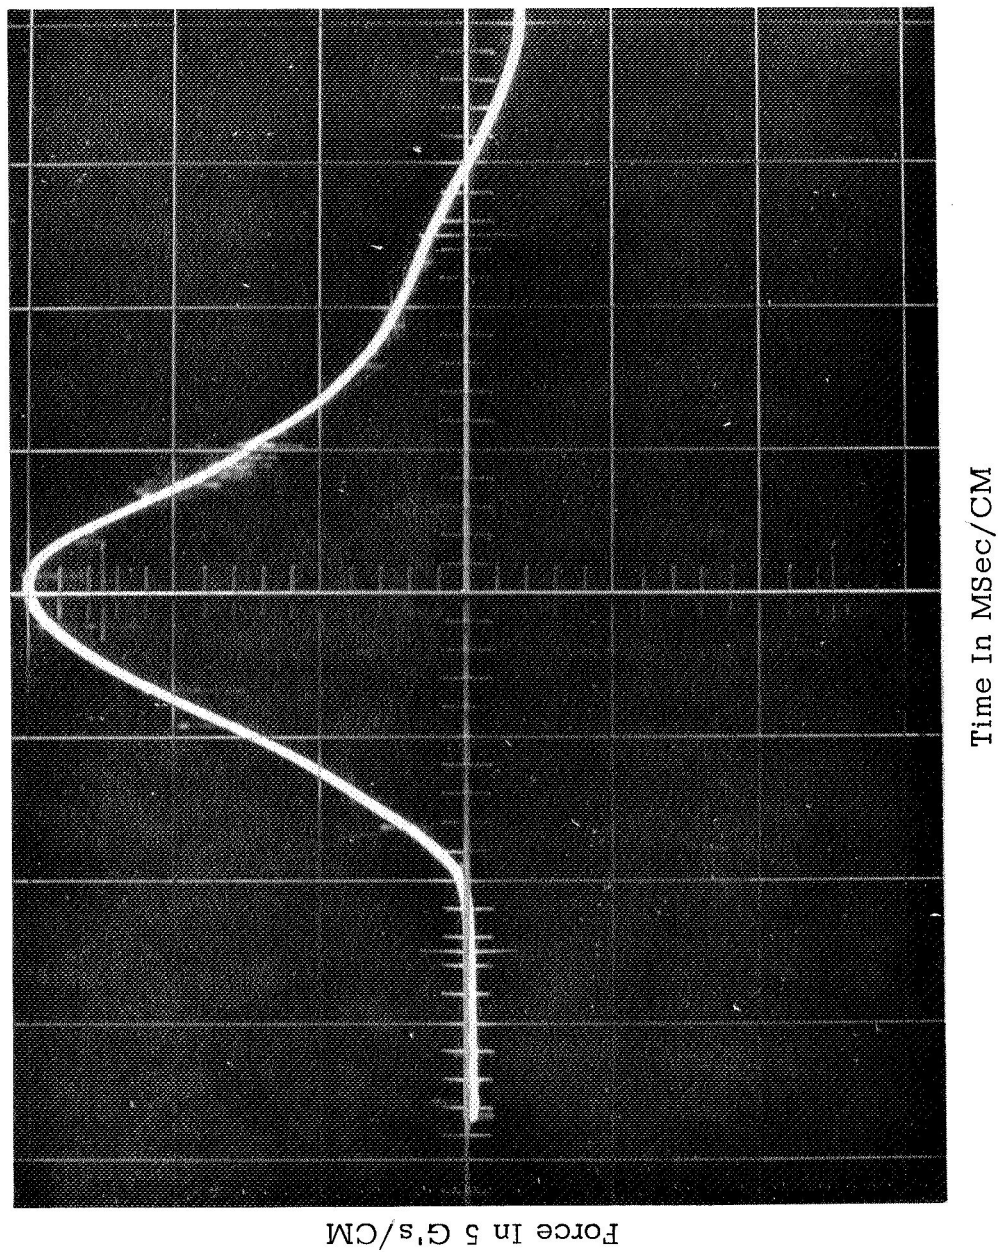
Figure 35.
Typical Shock Pulse Waveform During Shock Test For Burst Discs,
Seal-Off Valves, And Vacuum Probes

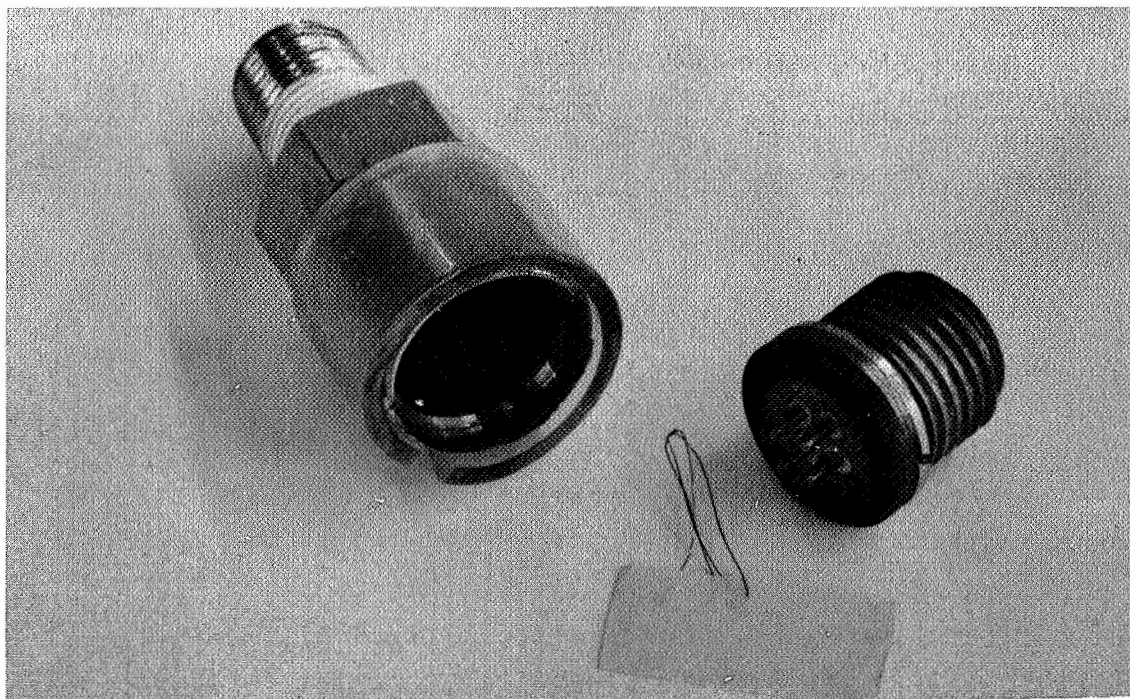
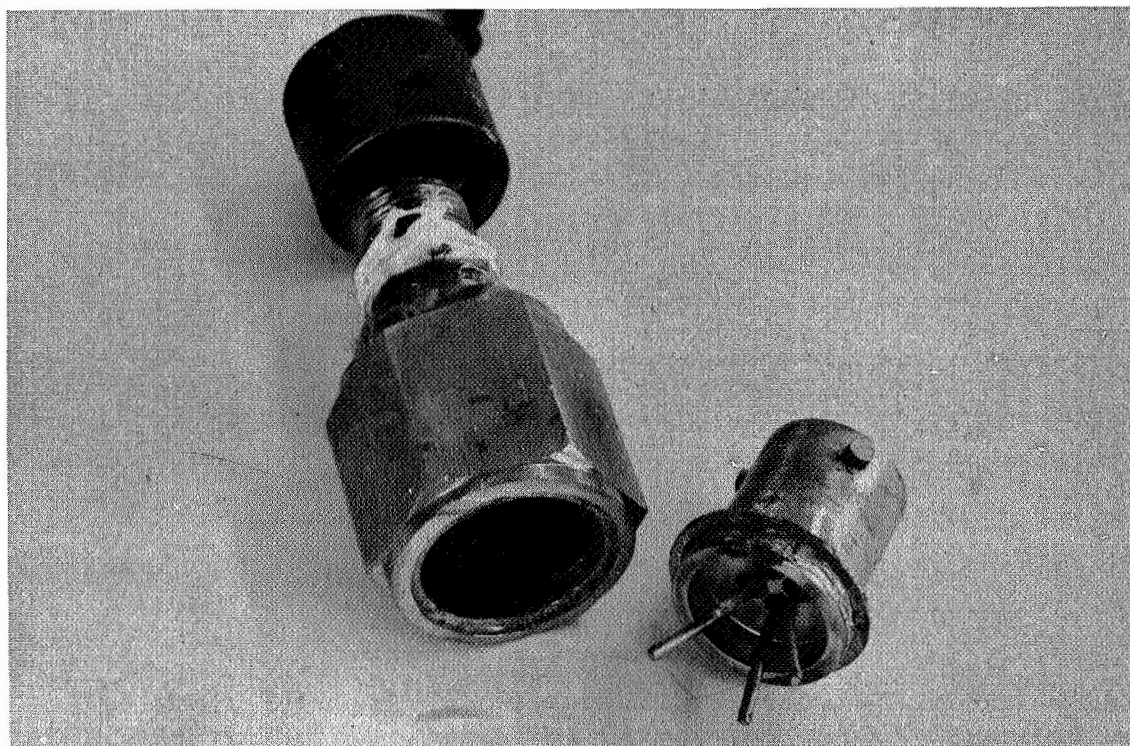
Figure 36.

Fredericks Vacuum Probe — Note Sensing Elements Broken Completely From Mounting Posts

Cryolab Vacuum Probe — Typical Failure Of Vacuum Probes After The Accelerated Life Test

Of the eight Fredericks vacuum probes tested, one failed at 40 g's and two failed at 55 g's. Only one failure was encountered with the Cryolab vacuum probes at 55 g's. Pages 104 through 109 are the data sheets for the accelerated life test. Page 103 shows the typical failure encountered with the sensing wires breaking at the mounting post.
